SERVICE BULLETIN

SPECIAL INSPECTION TO INCREASE THE TBO FOR ROTAX® ENGINE TYPE 912 (SERIES) SB-912-005UL

SPECIAL INSPECTION TO INCREASE THE TBO FOR ROTAX® ENGINE TYPE 912 A (SERIES) SB-912-005 R3

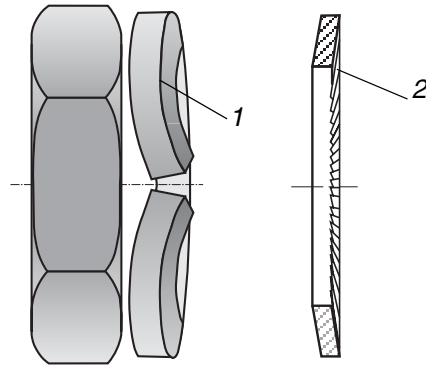
Fig. 1
Friction washer

If hex. nut is still secured by a lock washer, it has to be exchanged for the friction washer (1) according to current Maintenance Manual (Heavy Maintenance).

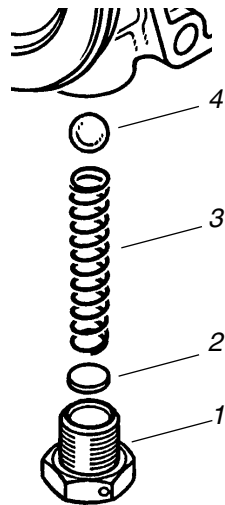
Fig. 2
Improved oil pressure control

From engine S/N 4,005.186 onwards, to improve oil pressure control the following parameters of the relief valve were changed. Free length of the compression spring (3) was reduced from 46 mm (1.81 in.) to 39 mm (1.55 in.). Spring rate was changed by increase of wire dia. from 0,8 mm (.031 in.) to 0,9 mm (.035 in.), and dia. of ball was increased from 8 mm (.31 in.) to 8,5 mm (.33 in.). If existing, remove shim (4), but if specified oil pressure can't be reached, adjust pressure by adding shim again.

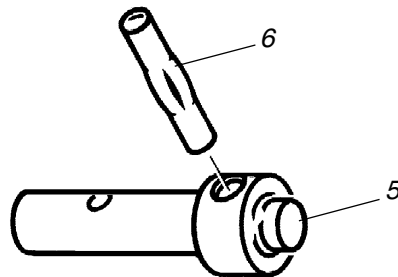
Fig. 3
Oil pump shaft

From engine S/N 4,152.101 onward the follower in the oil pump shaft (6) was changed to notched pin (5) instead of the former dowel tube.

At a renewal of components change oil pump to the version with the 16 mm (.63 in.) long rotors.

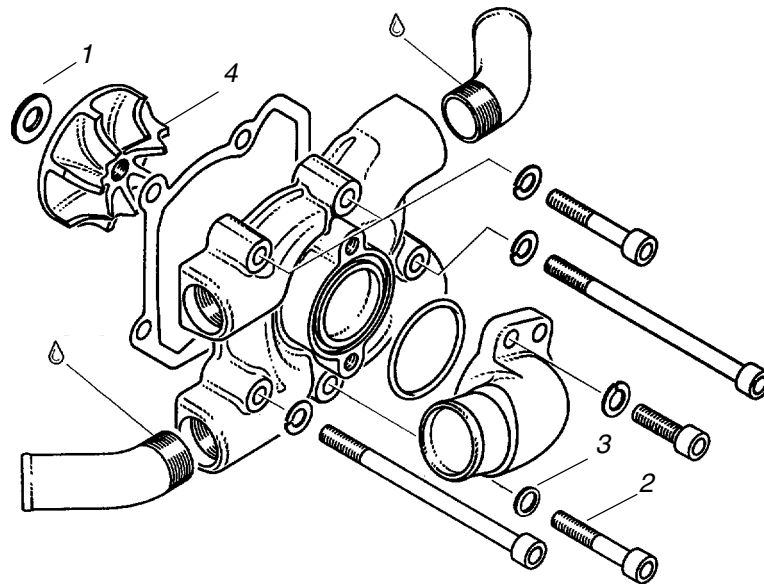
Fig. 4
Water pump

Operation of the engine without antifreeze in the coolant is not permitted since increased formation of corrosion. Therefore the material of the pump shaft was changed with engine S/N 4,152.414. Because of galvanic reactions, caused by the use of various materials, the washer (1) and the screw (2) are of stainless steel since engine S/N 4,152.607.

Remove, checking and installation in according to current Maintenance Manual (Heavy Maintenance).

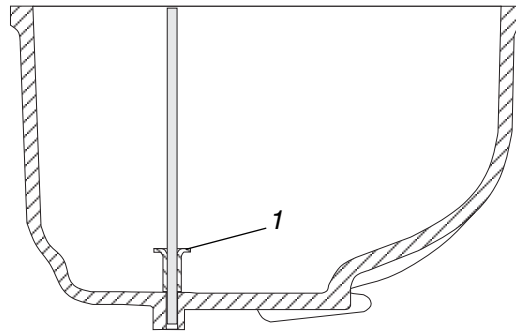
Fig. 5
Check of float chamber

Remove float chamber and lift out both floats. If float chamber is still without distance pieces (1), part no. 861920, add them now, thus avoiding possible sticking of the floats in the float chamber.

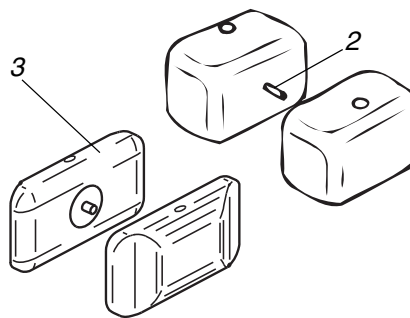
Fig. 6
Check of float

Check support pin (2) of floats. At heavy wear of float bracket contact faces, caused by excessive vibration, exchange these floats to floats of modified shape and renew float bracket as required.

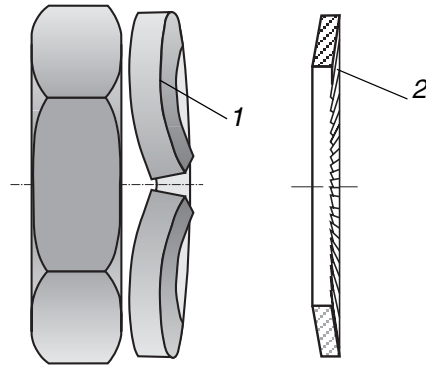
Fig. 1
Friction washer

If hex. nut is still secured by a lock washer, it has to be exchanged for the friction washer (1) according to current Maintenance Manual (Heavy Maintenance).

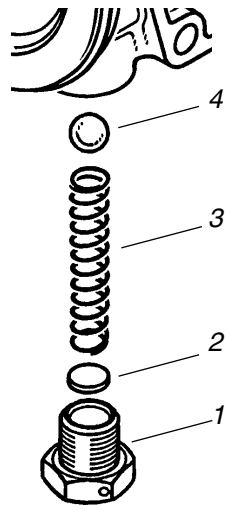
Fig. 2
Improved oil pressure control

From engine S/N 4,005.186 onwards, to improve oil pressure control the following parameters of the relief valve were changed. Free length of the compression spring (3) was reduced from 46 mm (1.81 in.) to 39 mm (1.55 in.). Spring rate was changed by increase of wire dia. from 0,8 mm (.031 in.) to 0,9 mm (.035 in.), and dia. of ball was increased from 8 mm (.31 in.) to 8,5 mm (.33 in.). If existing, remove shim (4), but if specified oil pressure can't be reached, adjust pressure by adding shim again.

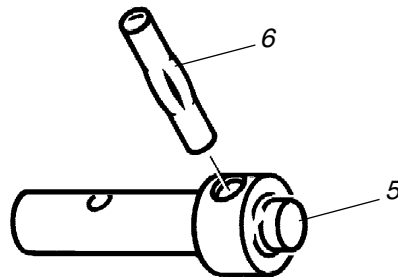
Fig. 3
Oil pump shaft

From engine S/N 4,076.068 onward the follower in the oil pump shaft (6) was changed to notched pin (5) instead of the former dowel tube.

At a renewal of components change oil pump to the version with the 16 mm (.63 in.) long rotors.

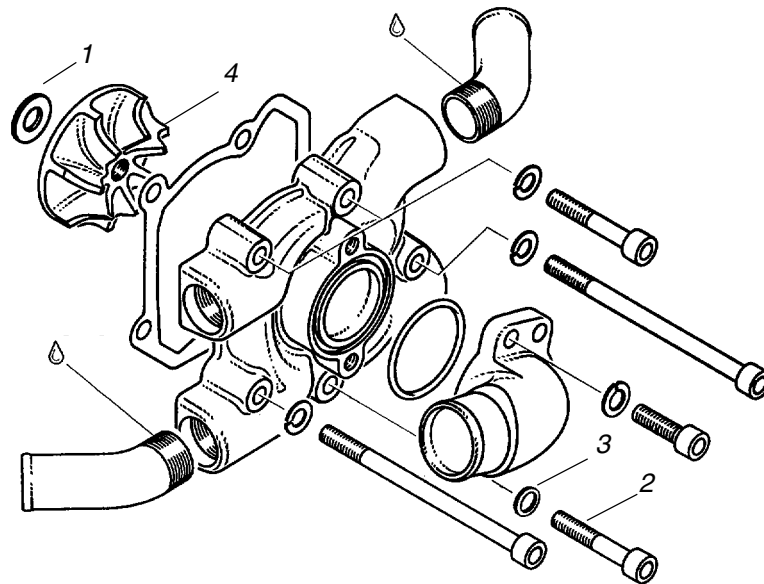
Fig. 4
Water pump

Operation of the engine without antifreeze in the coolant is not permitted since increased formation of corrosion. Therefore the material of the pump shaft was changed with engine S/N 4,076.122. Because of galvanic reactions, caused by the use of various materials, the washer (1) and the screw (2) are of stainless steel since engine S/N 4,076.178.

Remove, checking and installation in according to current Maintenance Manual (Heavy Maintenance).

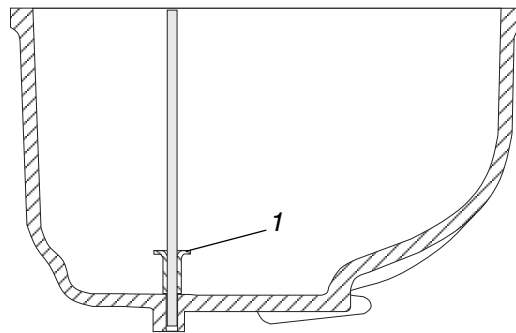
Fig. 5
Check of float chamber

Remove float chamber and lift out both floats. If float chamber is still without distance pieces (1), part no. 861920, add them now, thus avoiding possible sticking of the floats in the float chamber.

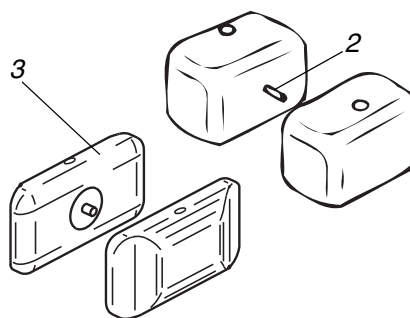
Fig. 6
Check of float

Check support pin (2) of floats. At heavy wear of float bracket contact faces, caused by excessive vibration, exchange these floats to floats of modified shape (3), part no. 861183 as per amendment no. 37-01 and re-new float bracket as required.
