# SERVICE BULLETIN

## GROUND CONNECTION FOR PICK-UP WIRING FOR ROTAX® ENGINE TYPE 912 (SERIES) SB-912-007 UL

**Ground connection for pick-up wiring, ROTAX Engine Series Type 912**

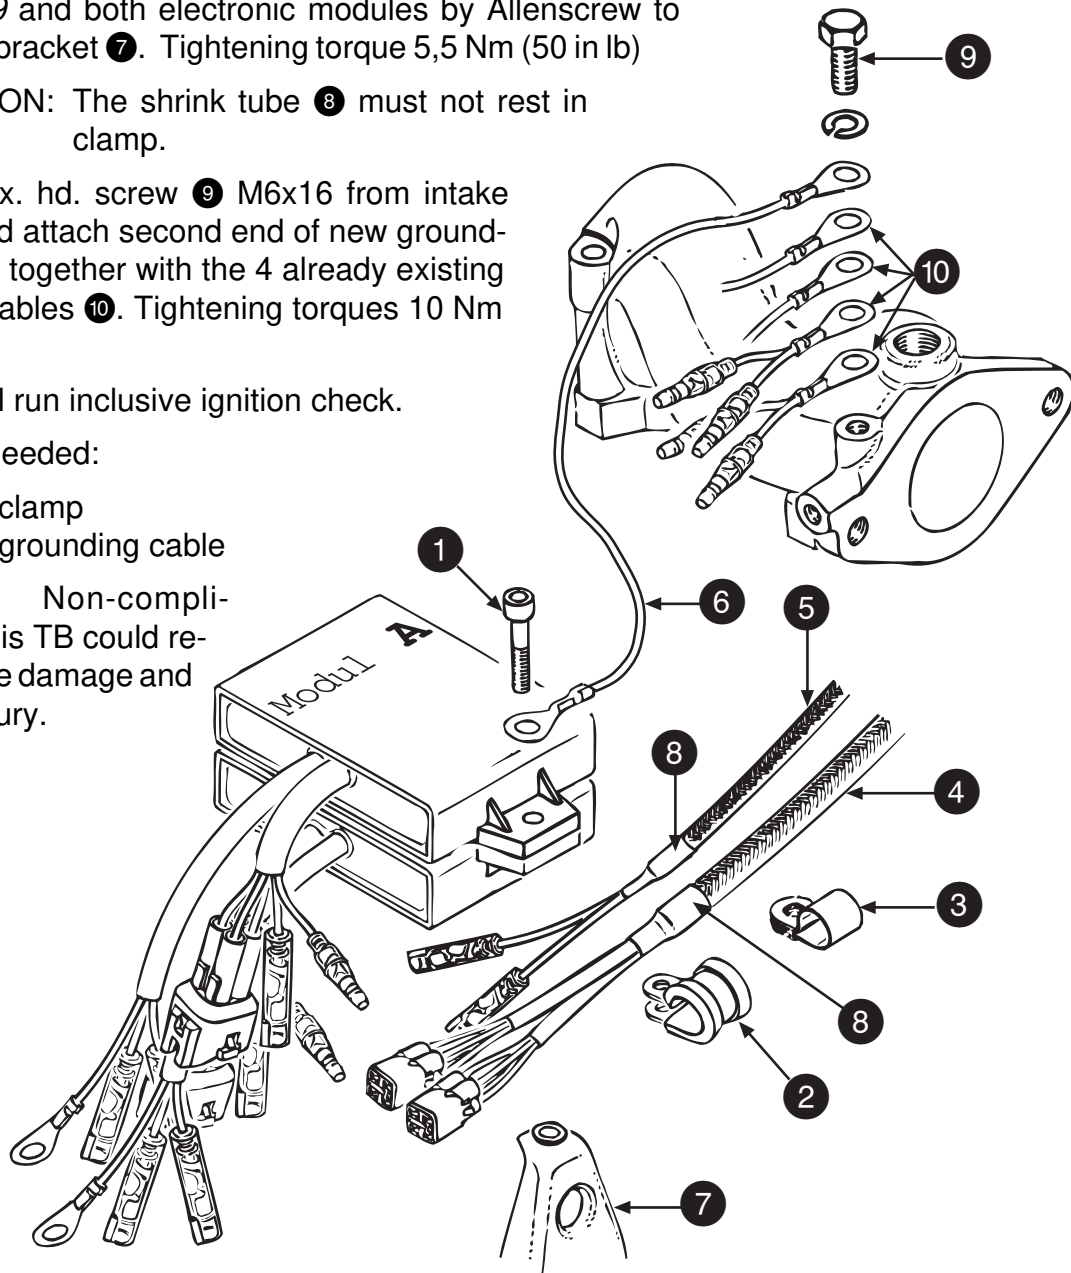
- Reason:** On the current installation of the ignition unit, troubles could occur in areas with heavy radio transmission. Because of the good result of the respective tests for EMC (electro magnetic compatibility) all the engines affected have to be reworked.

- 1) Remove Allen screw ① M5x25 and the clamp ② with rubberlined inside.
- 2) Slide new clamp ③ ( without rubberlining) over the cable-assemblies ④ and ⑤ so far that the screening braid rests completely in the clamp.
- 3) The shorting cables have to be furnished with screening over the complete length. The sceening to be attached via short connection prices on the Allen screw ① together with grounding cable ⑥. On the ignition switch side the screening of the shorting cable has to be securely connected to ground too.
- 4) Attach new grounding cable ⑥ *part-no. 965 787*, clamp ③ *part-no. 851 119* and both electronic modules by Allenscrew to ignition coil bracket ⑦. Tightening torque 5,5 Nm (50 in lb)

■ **ATTENTION:** The shrink tube ⑧ must not rest in clamp.

- 5) Remove hex. hd. screw ⑨ M6x16 from intake manifold and attach second end of new grounding cable ⑥ together with the 4 already existing grounding cables ⑩. Tightening torques 10 Nm (90 in lb)

- 6) Perform trial run inclusive ignition check.

- 1x 851 119 clamp
- 1x 965 787 grounding cable

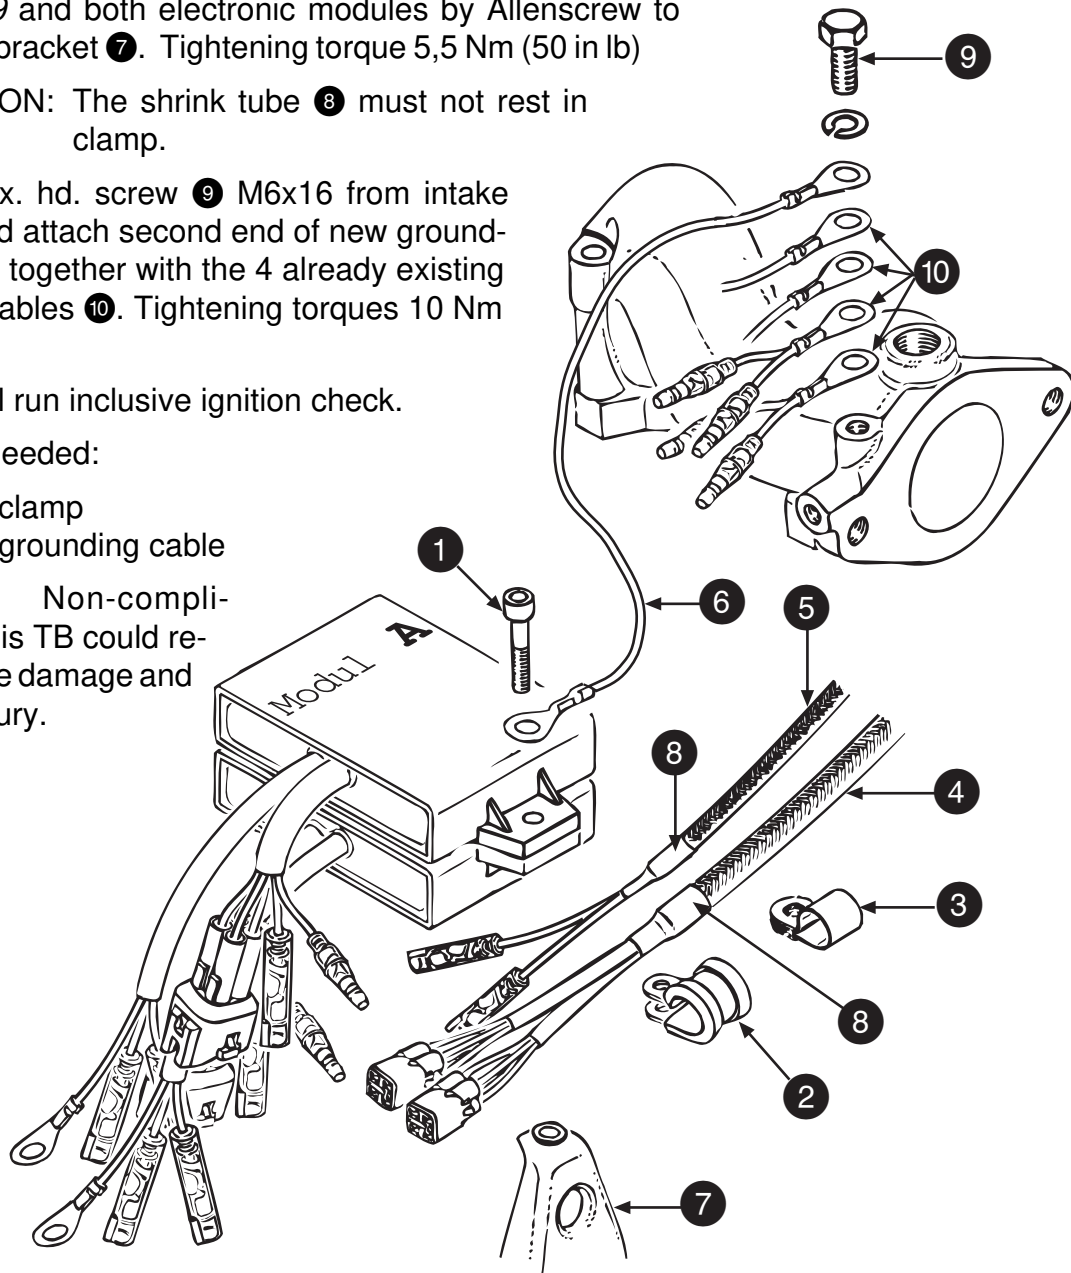
**Reason:** On the current installation of the ignition unit, troubles could occur in areas with heavy radio transmission. Because of the good result of the respective tests for EMC (electro magnetic compatibility) all the engines affected have to be reworked.

- 1) Remove Allen screw ① M5x25 and the clamp ② with rubberlined inside.
- 2) Slide new clamp ③ ( without rubberlining) over the cable-assemblies ④ and ⑤ so far that the screening braid rests completely in the clamp.
- 3) The shorting cables have to be furnished with screening over the complete length. The sceening to be attached via short connection prices on the Allen screw ① together with grounding cable ⑥. On the ignition switch side the screening of the shorting cable has to be securely connected to ground too.
- 4) Attach new grounding cable ⑥ *part-no. 965 787*, clamp ③ *part-no. 851 119* and both electronic modules by Allenscrew to ignition coil bracket ⑦. Tightening torque 5,5 Nm (50 in lb)

■ **ATTENTION:** The shrink tube ⑧ must not rest in clamp.

- 5) Remove hex. hd. screw ⑨ M6x16 from intake manifold and attach second end of new grounding cable ⑥ together with the 4 already existing grounding cables ⑩. Tightening torques 10 Nm (90 in lb)

- 6) Perform trial run inclusive ignition check.

- 1x 851 119 clamp
- 1x 965 787 grounding cable
