CHECKING OF THE CRANKCASE

ON ROTAX® ENGINE TYPE 912 AND 914 (SERIES)

SB-912-029 R3

SB-914-018 R3

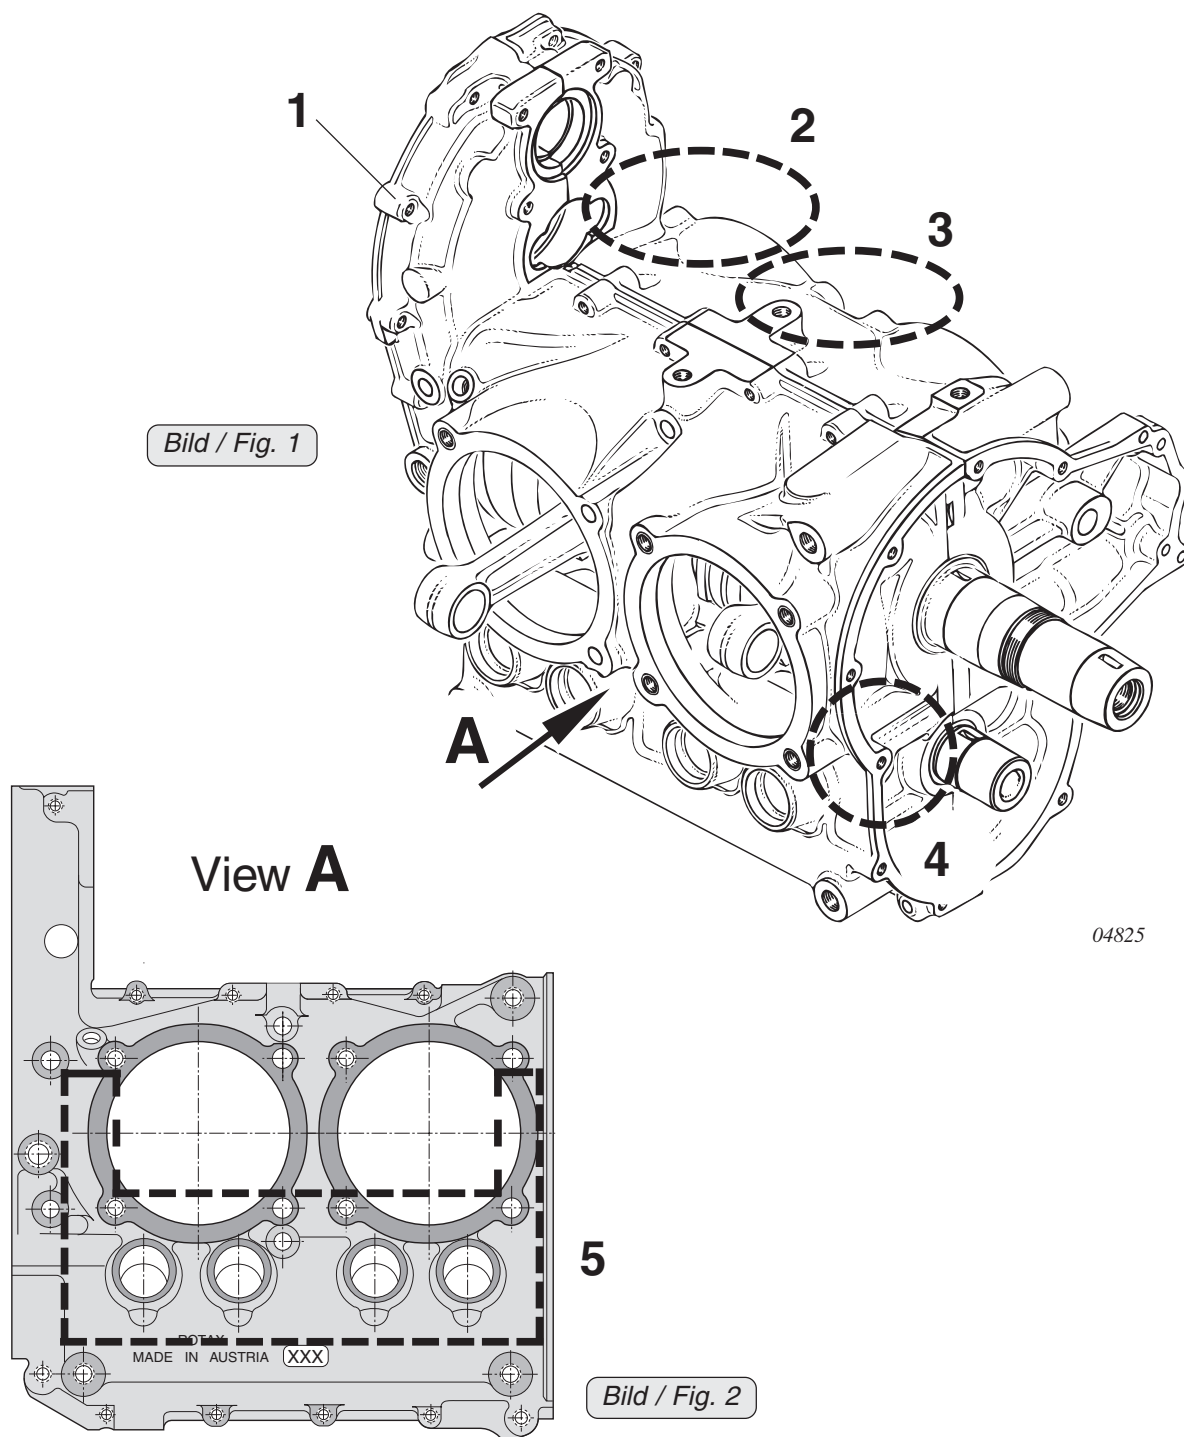
see fig. 1

One or more of the following could result in formation of cracks on the crankcase:

- Unapproved and untested modifications
- Improper carburetor synchronization
- Unsuitable idle speed (too low)
- Unsuitable engine suspension / non-neutralized vibrations
- Propeller balance out of tolerance
- Friction torque in the backlash range of gearbox not within tolerance
- Lack of maintenance
- Ground contact
- Excessive thermal strain
- Exceeding of maximum admissible engine speed
- Exceeding of maximum admissible manifold pressure

- Visually inspect the crankcase (1) and engine suspension for cracks in accordance with the relevant Maintenance Manual.

- in the area of cylinder 1 upper side (2)
- between cylinder 1 and 3 upper side (3)
- in the area of cylinder 4 lower right side (4) and
- detailed inspect in the area (5). See view **A** fig. 2.

For those engines using the ROTAX® cooling air baffle. Visually inspect for oil leaks in area (2) and (3). If leaks are found, then further investigation to determine the cause of the oil leak is required. If the exact origin of the leak can not be determined i.e. governor, then removal of the cooling air baffle must be required.

- If cracks are detected the nearest ROTAX® Authorized Distributor (see also our official ROTAX-Web-Site: www.rotax-aircraft-engines.com) has to be informed and if necessary the engines has to be removed from aircraft and must be returned to a ROTAX® Authorized Distributor.
- Reconnect negative terminal of aircraft battery (after installation of engine).
