SERVICE BULLETIN

CHECK OF SUPPORT BEARING ON THE CRANKSHAFT AND OF THE BEARING BUSHING IN THE PROPELLER GEARBOX ON ROTAX_® ENGINE TYPE 912/914 (SERIES) SB-912-046UL SB-914-031UL

SB-912-046 SB-914-031

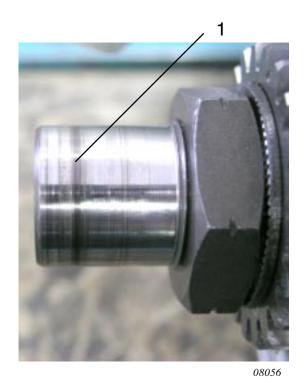
- CAUTION: All work has to be performed in accordance with the relevant Maintenance Manual.
- Fix the crankshaft.
- Remove the propeller gearbox.
- Detailled check of crankshaft journal (1) and the bearing bushing in the gearbox housing (2) for scoring marks in connection with discolouration.

If discoloration and grooves (1) are not removeable with Scotch Brite, engine must be sent to the authorized distributor responsible for the distribution area.

- ◆ NOTE: Conditional on operation, minimal or usual break-in marks are normal and can be ignored.
- If necessary clean the crankshaft stub with Scotch Brite until no discolouration is there. If the discolouration cannot be removed, engine must be sent to the authorized distributor responsible for the distribution area for repair/overhaul.

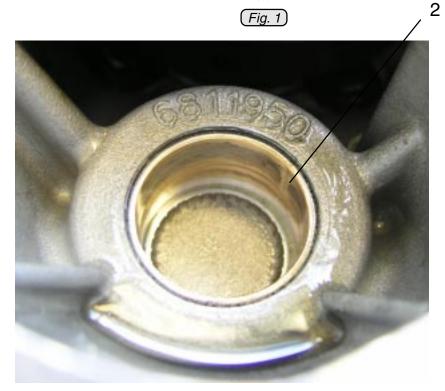
(Fig. 2

Replacement of propeller gearbox required if unusual scoring (2) in the bearing bushing is discovered.

- On signs of scoring marks in the bearing bushing replace the whole propeller gearbox and check the oil filter
 for metal chips. If unusual marks of metal chips are detected in the filter mat, empty and clean the oil tank. Carry
 out an oil change. The replaced propeller gearbox must be sent to the authorized distributor responsible for the
 distribution area.
