# SERVICE BULLETIN

## CHECK OF ALLEN SCREW M8X100 IN THE CRANKCASE ON ROTAX® ENGINE TYPE 912/914 SB-912-047UL SB-914-032UL

## CHECK OF ALLEN SCREW M8X100 IN THE CRANKCASE ON ROTAX® ENGINE TYPE 912/914 SB-912-047 SB-914-032

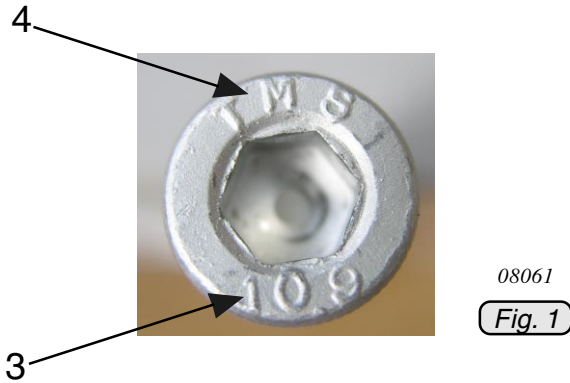
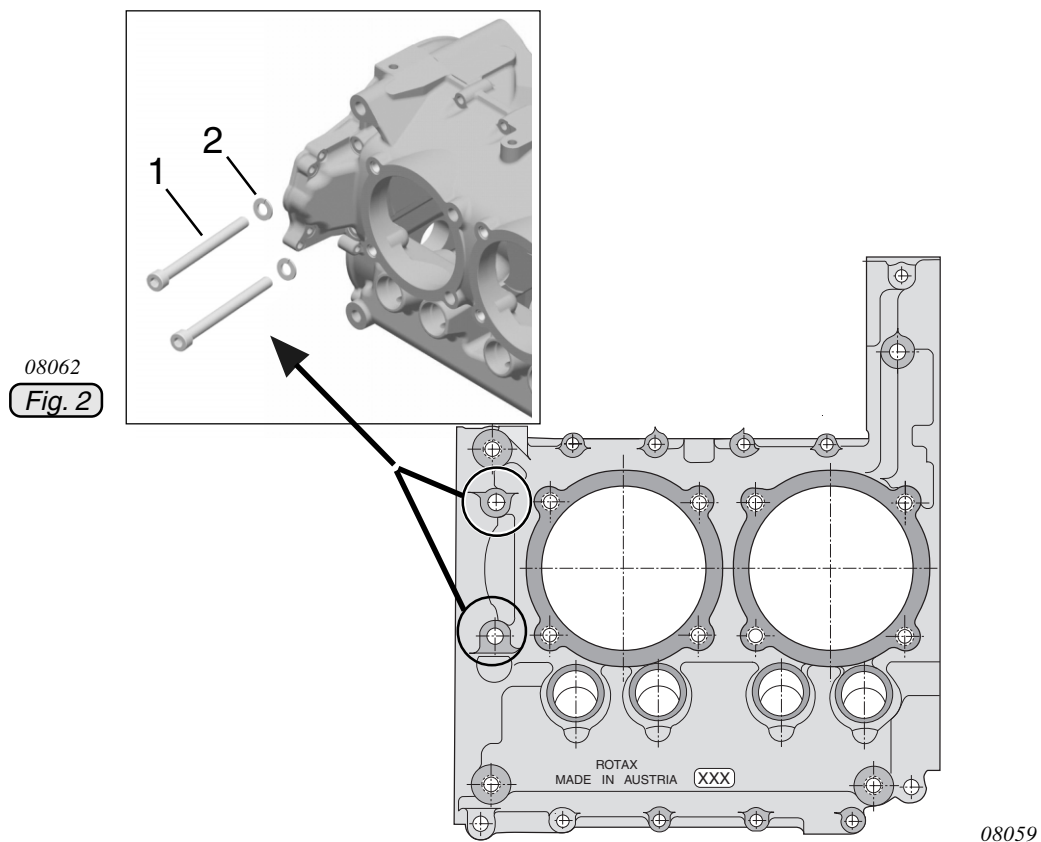
In limited number of cases a deviation in the production of the allen screw may result in cracking of screw head and possible loss of the screw head.

Only the 2 allen screws M8X100 (1) part no. 440427 are affected by the production deviation. They are installed in the crankcase on the cylinder side 1/3 between cylinder 3 and the electric starter.

Furthermore, only allen screws marked „TMS“ on the screw head are affected.

◆ **NOTE:** In addition to the quality marking 10.9 (3) the production code must be identified on the screw head. Allen screws with a production code of „TMS“ (4) may be affected and must be replaced in all cases.

- Replace affected allen screw (1) including lock washer (2). Tightening torque 30 Nm (265 in.lb.).

■ **CAUTION:** If both allen screws are affected and must be replaced, allen screws and lock washers must be replaced one at a time. Remove and replace the first allen screw and lock washer before loosening or removing the second screw. After the first screw and lock washer has been replaced, remove the second allen screw and install a new allen screw and lock washer.
