SERVICE BULLETIN

CHECKING ECCENTERS AND FUEL PUMP PLUNGERS FOR ROTAX® ENGINE TYPE 912 (SERIES) SB-912-049UL

FOR ROTAX® ENGINE TYPE 912 (SERIES) SB-912-049

Checking eccenters and fuel pump plungers on ROTAX® engine type 912 (Series).

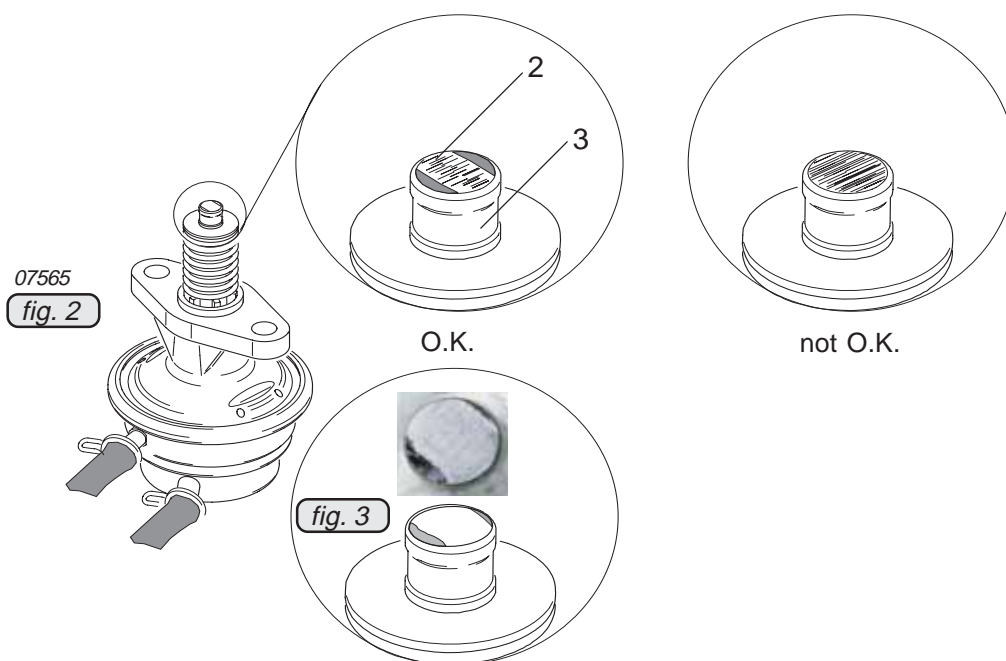
Because of roughness surface on the eccenter in the propeller gearbox, this can result in abrasion on the fuel pump plunger.

- Remove fuel pump
- Detailed check of the surface (2) of the fuel pump plunger (3). The contact surface with the eccentric must have no fretting or scoring marks. Wear traces that appear slight are permissible. See Fig. 3. The width of the contact area is greater depending on the running time already completed. If traces of wear are visible on the entire diameter of the pump plunger, the fuel pump must be replaced due to too much wear.

- If OK, then reinstall fuel pump with a new gasket.
- Check the magnetic plug for increased metal content. See Fig. 1.

Steel chips in small quantities as shown in Fig. 1 are acceptable as long as the layer thickness is less than 3 mm. If the findings are unclear, the oil circuit must be flushed and a new oil filter installed.

If the surface of the pump plunger and/or eccentric is found to have unusual wear, then the propeller gearbox with drive gear and fuel pump must be sent to the authorized distributor or their service center for repair.

If a quantity of chips (less than 3 mm) is found on the magnetic plug (1) and wear is found on the plunger of the fuel pump, then the eccenter and the fuel pump must be replaced.

The propeller gearbox with drive gear must be sent to the authorized distributor or their service center for repair.
