# SERVICE BULLETIN

## REPLACEMENT OF WASHER PART NO. 944072 (FLY WHEEL HUB) FOR ROTAX® ENGINE TYPE 912 AND 914 (SERIES)

SB-912-058UL

SB-914-041UL

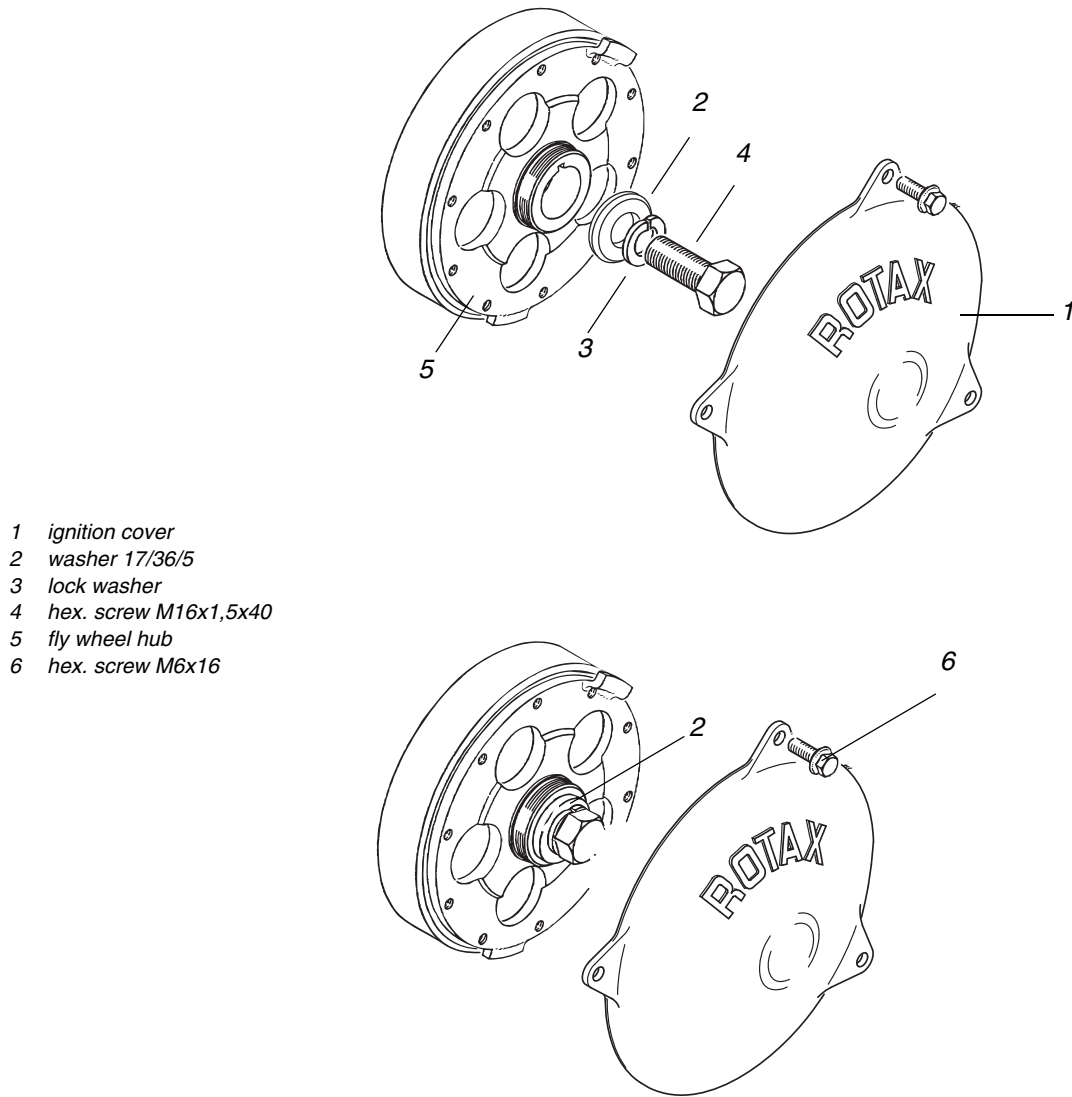
**Fig. 1**

A deviation in hardening process could cause an exceeding of hardness of certain washer. This deviation could lead to cracks in the washer and could cause loosening of fly wheel, ignition failure or engine damage.

#### **magneto ring, fly wheel hub, ignition cover**

See fig. 1.

1. Remove ignition cover (1).
2. Lock the crankshaft in accordance with the relevant Maintenance Manual (Line).
3. Remove hex. screw (4) in accordance with the relevant Maintenance Manual (Heavy).

◆ NOTE: Fly wheel hub does not have to be removed unless it has become loose.

■ CAUTION: If the fly wheel hub has loosened during the disassembly and/or in case of doubt, then remove, clean and install the fly wheel hub in accordance with the relevant Maintenance Manual. In this case the tightening torque is 45 Nm (33.2 ft.lb) + 180° angle to rotation.

4. Install hex. screw (4). **Tightening torque 120 Nm (89 ft.lb).**

■ CAUTION: During installation the new washer (2) part no. 944072 must be used.

5. Remove locking pin of crankshaft in accordance with the relevant Maintenance Manual.
6. Check trigger coil gap, if necessary adjust it in accordance with the relevant Maintenance Manual.
7. Install ignition cover (1). The hex. screws (6) are locked with Loctite 221. Tightening torque 5 Nm (44 in. lb.).
