CHECKING OF THE CRANKSHAFT JOURNAL (POWER TAKE OFF SIDE) FOR ROTAX® ENGINE TYPE 912 AND 914 (SERIES)

SB-912-059UL

SB-914-042UL

SB-912-059

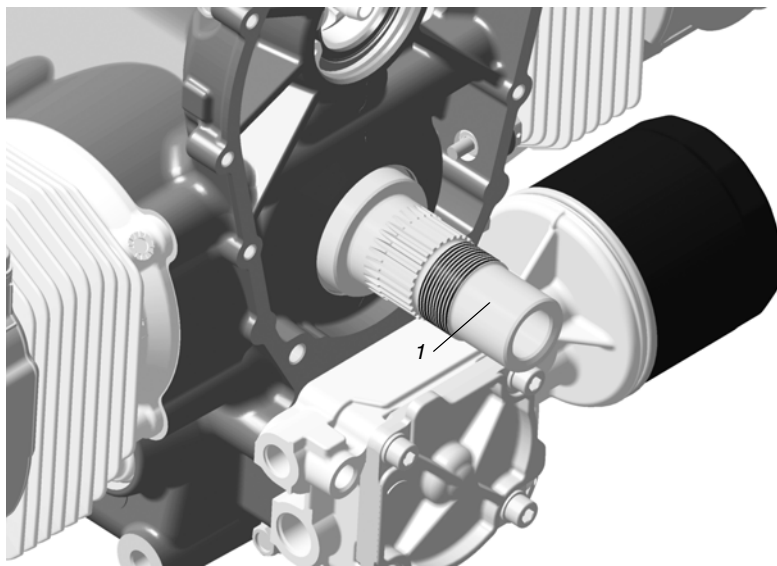
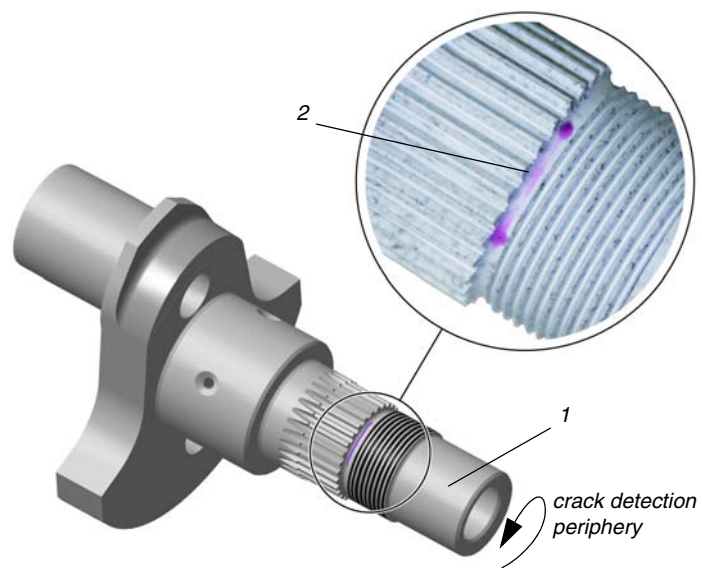
Fig. 1
crankshaft journal

Due to a deviation in the manufacturing process some crankshafts may have a crack formation occur on the power take off side. These cracks can cause a breakage of the crankshaft support bearing and may lead to engine stoppage.

- Detailed crack detection in the area (2) of the thread runout using penetration test. Perform this test in accordance to the requirements of the applicable aviation authority in your region for non destructive testing (NDT) and according to DIN EN 571 or equivalent.

- 1 crankshaft
- 2 detailed crack detection

- ◆ NOTE: Protect the crankcase against contamination by the test material.
 - CAUTION: In case of crack or doubt contact your aircraft manufacturer and your nearest authorized ROTAX aircraft engine distributor. The engine must not be taken into operation until the cause has been identified and eliminated.
