# Checking of the cylinder head assy. 2/3 for ROTAX® Engine Type 912 and 914 (Series)

# Checking of the cylinder head assy. (2/3) for ROTAX® Engine Type 912 and 914 (Series)

This ASB revises ASB-912-062/ASB-914-044 Revision 1

ATA System: 72-30-00 cylinder head

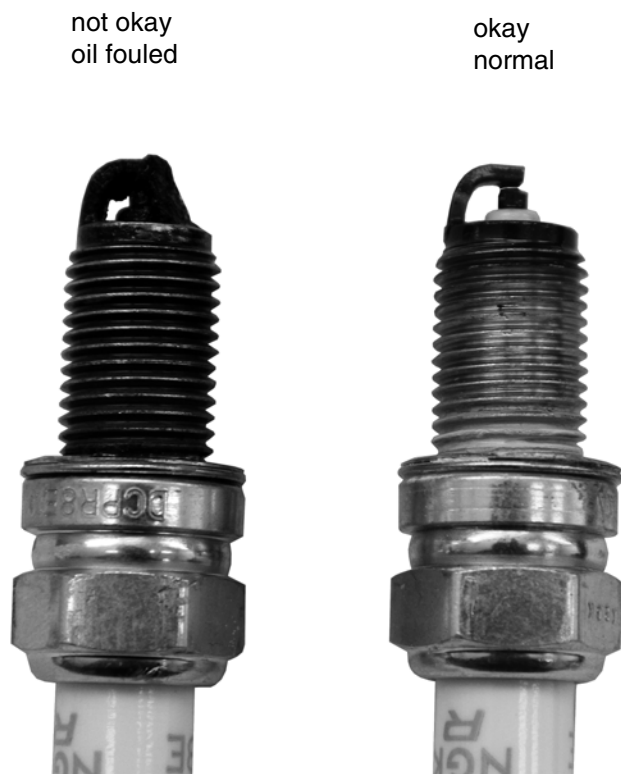
*Fig. 1  
spark plug*

Due to a deviation in the manufacturing process some cylinder heads may have an oil leak in the intake channel in the area of the valve guide. There is a possibility of small machined through holes, which can increase the oil consumption which may result in an engine stoppage.

**NOTE:** Unusual deposits (excessive carbon or oil) on the spark plugs are an indication of a defective cylinder head which must be replaced. Figure 1 shows comparison between a used spark plug in normal condition and one that is not.

Affected spark plugs with such deposits shown in chapter 4 Fig. 1, have to be removed and can not be reinstalled.

If excessive deposits (oil or carbon) are found on the spark plugs the cylinder head must be replaced in accordance with the relevant Maintenance Manual (Heavy) and any relevant aircraft manufacturer instructions.
