SERVICE BULLETIN

Periodic inspection of the float buoyancy for ROTAX® Engine Type 912 and 914 (Series)

ATA System: 73-00-00 Fuel system

MANDATORY

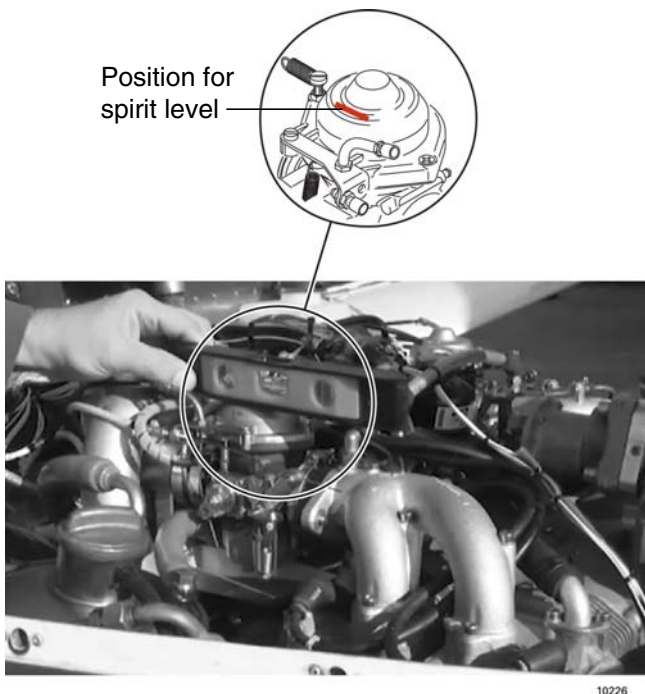
Fig. 1

Step	Procedure
1	Bring the float chamber to horizontal position (level the aircraft, if necessary and check the horizontal position with a spirit level). See Fig. 1.
2	Engine Series 912: Run the engine at idle for approx. 1-2 minutes without electric fuel pump. Engine Series 914: Run the engine at idle for approx. 1-2 minutes with main fuel pump.
3	Switch off the engine and follow safety notice chap. 3.
4	Remove the return spring (1). See Fig. 2.
5	Remove 4 Philips head screws (2). Remove rotary valve housing (3) with the gasket. See Fig. 2.
6	Remove the air vent line (4). See Fig. 2.

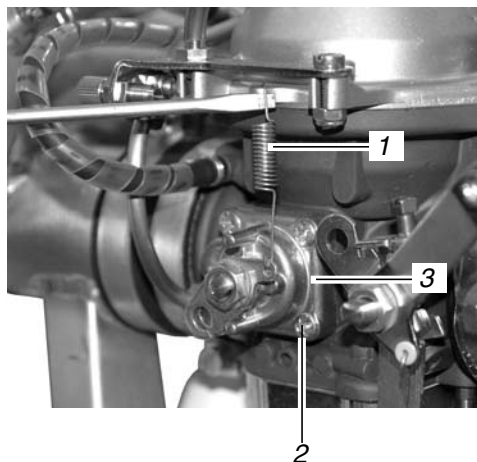
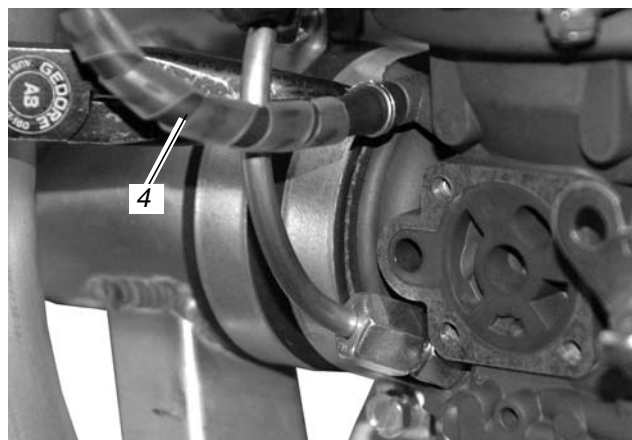
Fig. 2

- 1 Return spring
- 2 Philips head screw M4x14
- 3 Rotary valve housing
- 4 Air vent line

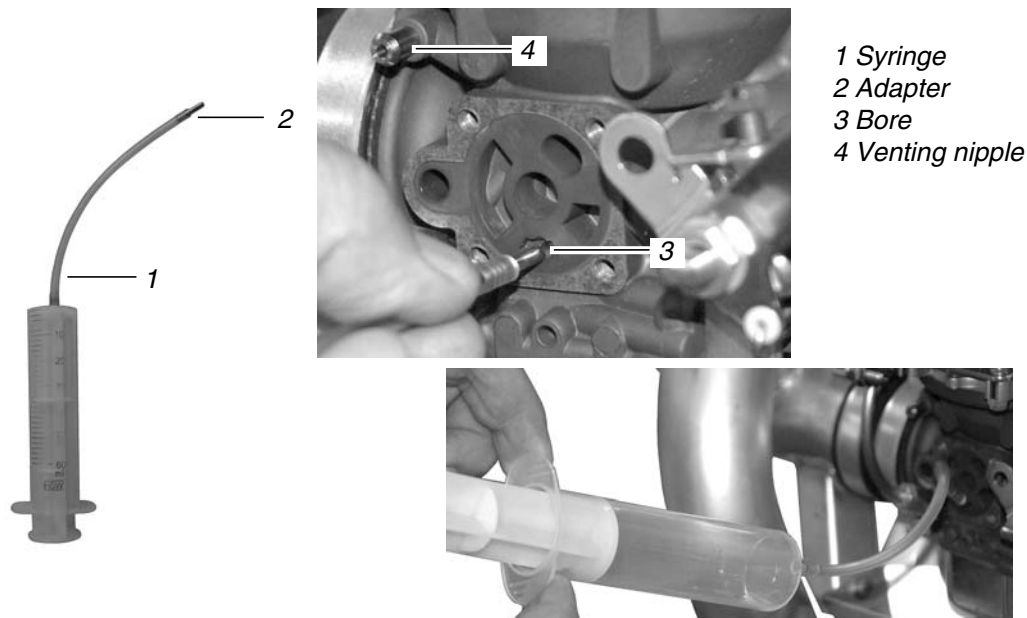
Fig. 3

Step	Procedure
1	Fill the syringe (1) with 40-50 ml of fuel.
2	Connect syringe to the adapter (2) using a transparent fuel hose
3	Fuel hose and adapter must be free from air bubbles.
4	Insert the adapter (2) in the lower bore (3) of the carburetor housing. Ensure a firm fit.

During the following inspection of the volume, carefully fill the float chamber with a syringe until the fuel leaks from the venting nipple (4). This process should take about 5 seconds. Record capacity before the filling operation. The capacity can be determined by reading the scale of the syringe.

Step	Procedure
5	Fill the float chamber until the fuel leaks from the venting nipple.
6	Determine the volume.
7	Perform the same inspection on the second carburetor.
8	The results of the measurement must be documented in the maintenance records.

Filling volume in float chamber	Evaluation
23 ml - 40 ml	Floats are OK, the float level is within the limit.
less than 23 ml	Significant deviation of the float levels. A detailed inspection of the floats or their weight is necessary. See section. 3.5).
more than 40 ml	Significant deviation of the float levels. Repeat inspection to avoid incorrect measurements. See section 3.1.1). A detailed inspection of the carburetor and floats or their weight is necessary. See section. 3.5). Check float needle valve for any leakage and check setting of the float bracket.

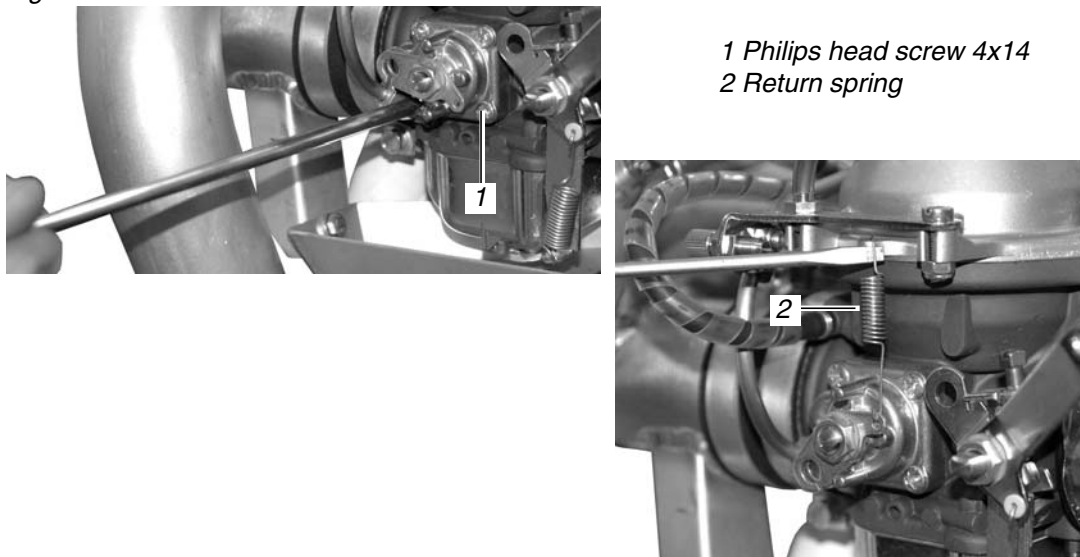
Fig. 4

Step	Procedure
1	Install the venting line.
2	Install rotary valve with new gasket.
3	Secure first 2 threads of the Philips head screw 4x14 (1) with LOCTITE 243.
4	Install the return spring (2).

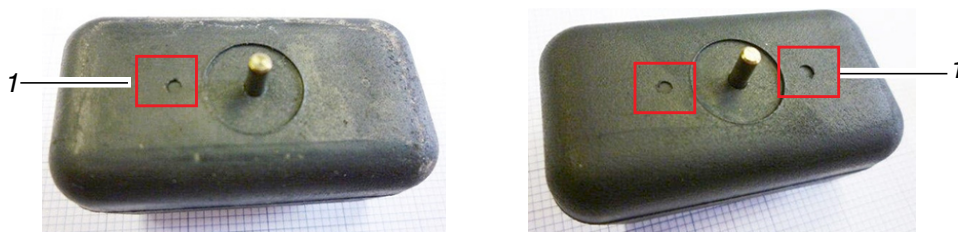
Fig. 5

NOTE: For traceability some floats (new but also already installed) show one or two markers. The imprinting is shown in Fig. 5. These markers have no effect on the function of the floats.

1 Marker

Only floats without weight control markers or according to SB-912-067/ SB-914-048 have to be changed. Already marked floats (see Fig. 1) must not be changed.

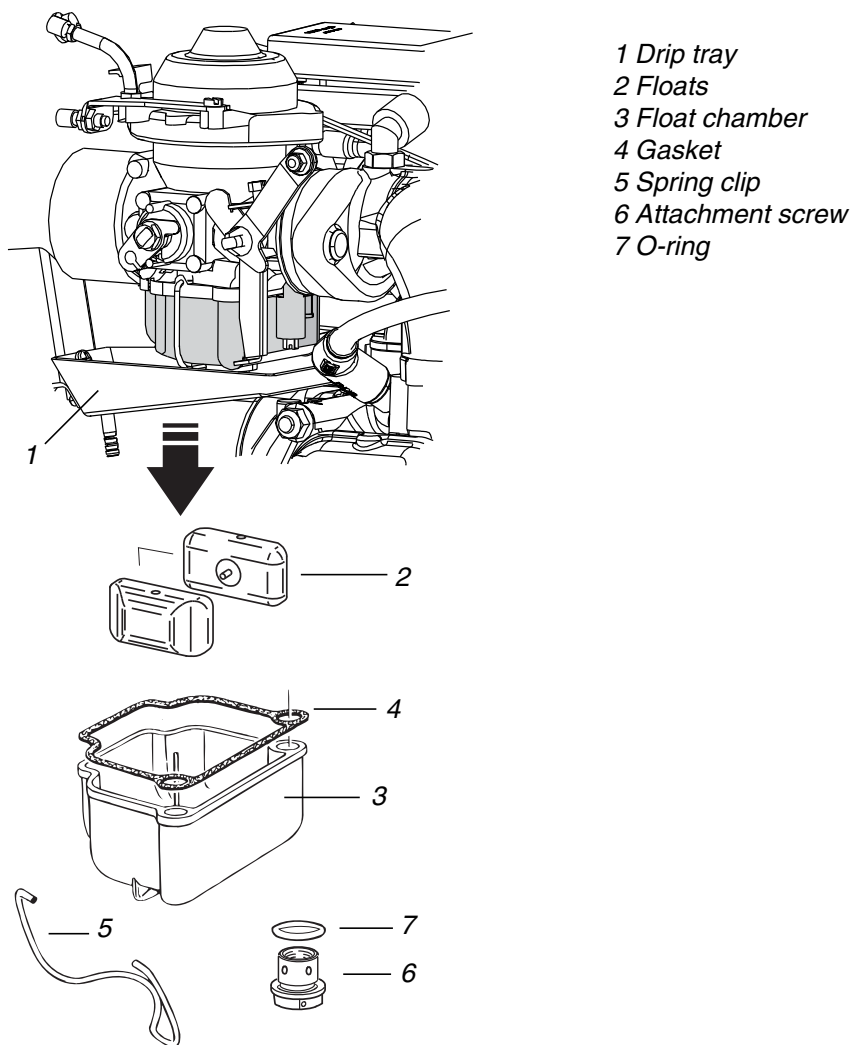
Fig. 6

Step	Procedure
1	Remove drip tray (1).
2	Visual inspection of the carburetor and its mechanical actuation.
3	Remove spring clip (5) or for ROTAX 914 Series loosen cap screw (6) and remove with O-ring (7).
4	Remove float chamber (3), gasket (4) and the two floats (2)

Step	Procedure
1	Remove the gasket (4) from the float chamber and for ROTAX 914 Series exchange the O-ring (7).
2	Install float chamber (3) with gasket (4) and both floats (2).
3	Close spring clip (5) or for ROTAX 914 Series install the attachment screw (6) including O-Ring (7). Tightening torque of attachment screw 5.5 Nm (48.7 in.lb).
4	Install drip tray (1) and/or accessories according to the instructions of the aircraft manufacturer.
